DOT/FAA/CT-93/1

Vertical Drop Test of a Metro III Aircraft

June 1993

Final Report

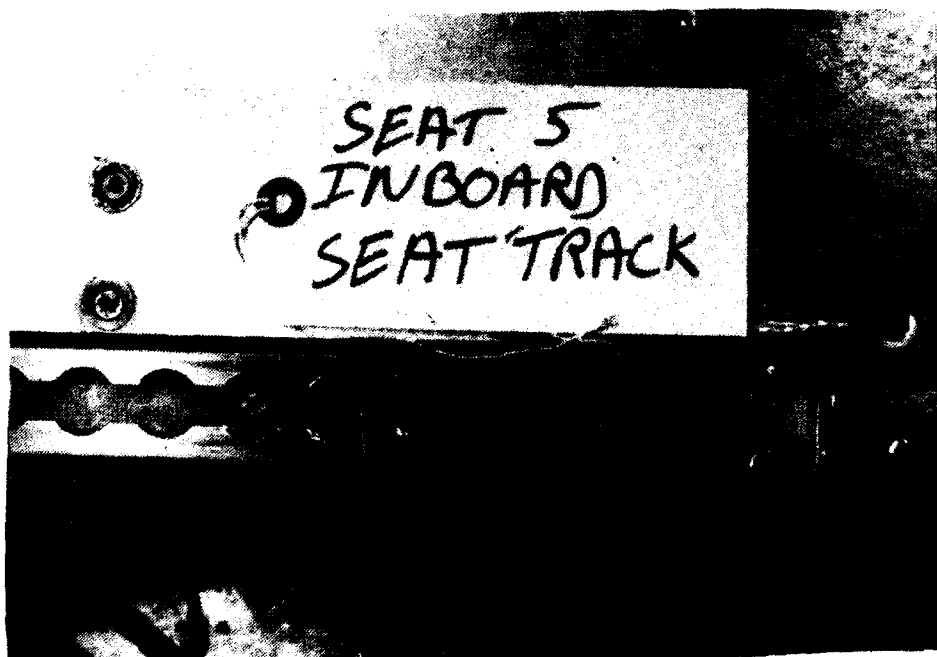
FIGURE 29. POST TEST SEAT TRACK, SEAT 5

Figure 26 is a post-test view of seat 5. Figures 27 and 28 show the inboard and outboard aft legs respectively, and figure 29 shows the damage to the seat track.

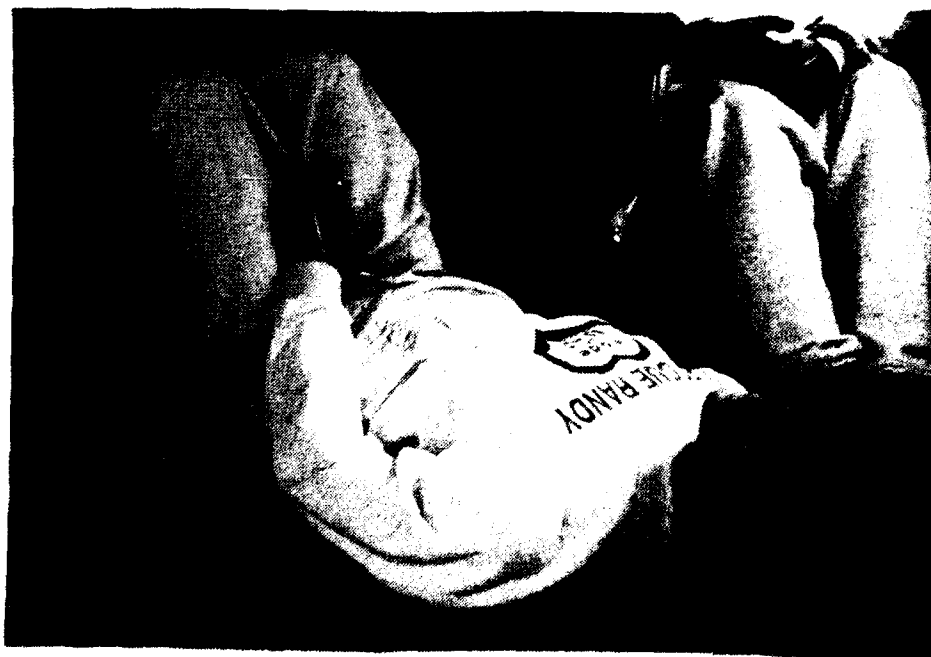
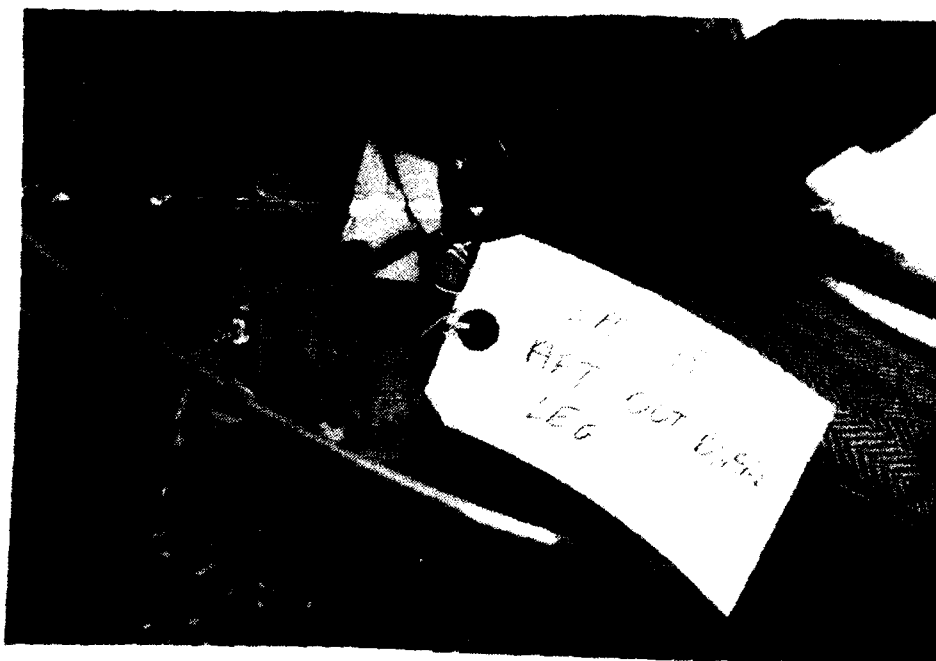
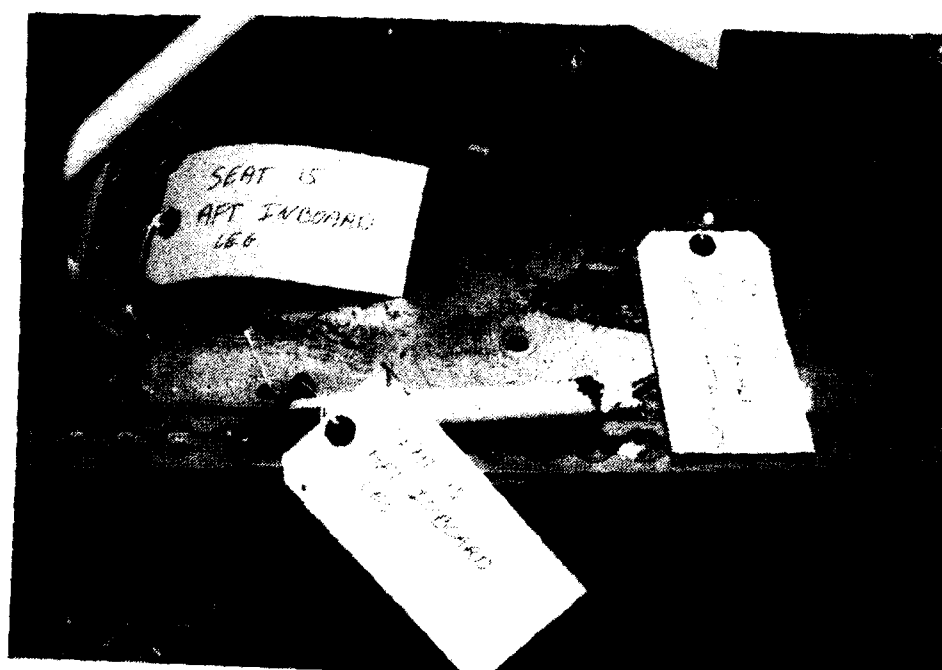
The damage to seat 15 can be seen from a variety of angles in figures 49, 50 and 51.

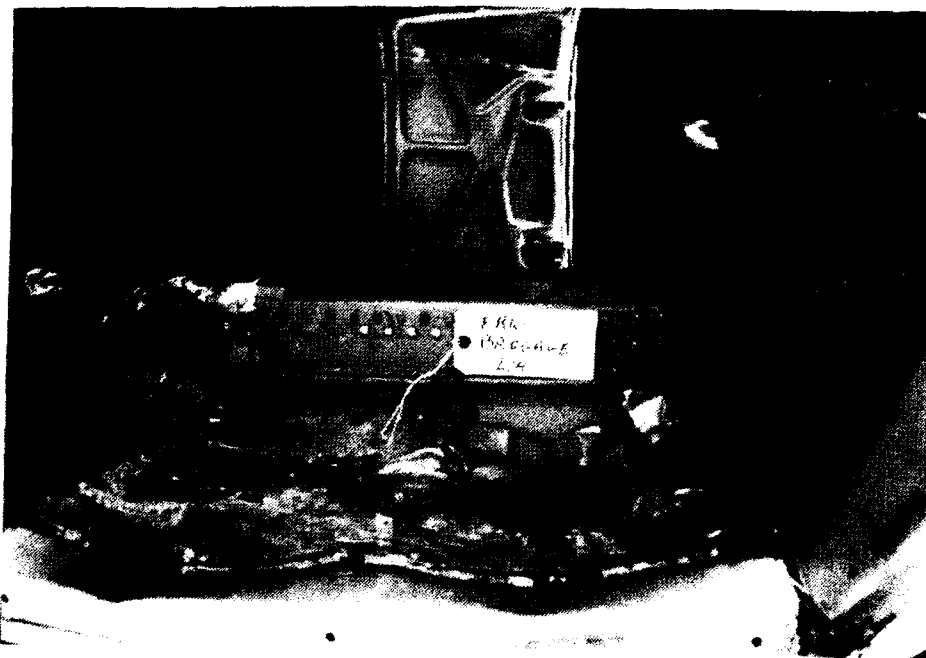
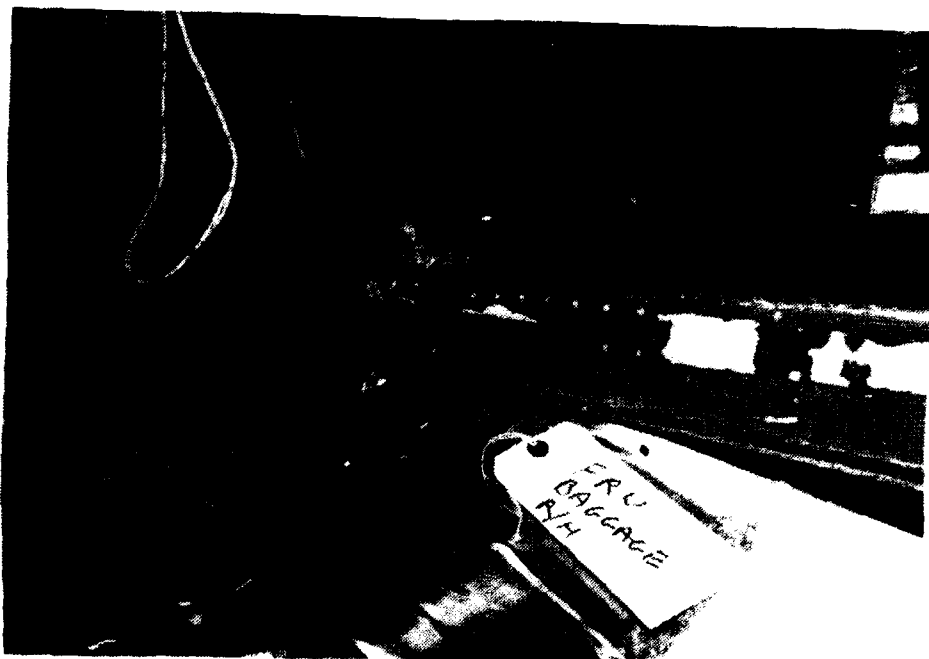
Figures 59, 60 and 61 view the inside of the forward baggage compartment after the test.
